Post Weld Heat Treatment Qualification of Type 304L Stainless Steel Weld Metal

Abdulnaser Hamza Fadel

Al Zawia University, Faculty of Natural Resources

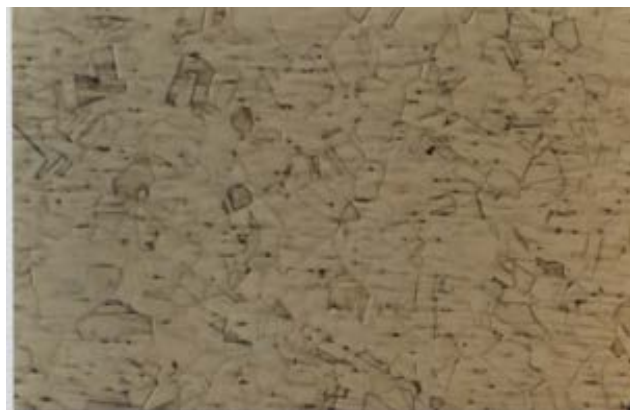
Fig. 1 Microstructure of the base metal as-received after streicher testing – 200X.

The microstructure of the as-received base metal obtained after streicher screening corrosion test (electro etching in 10% oxalic acid) is introduced in Fig.1. below

showing no signs of carbide precipitation at high angle grain boundaries could be observed indicating no sensitization. However Fig.2 introduces the microstructure of the same specimen but subjected to sensitizing annealing at 650°C for 60 min. Some isolated precipitates are observed at high angle boundaries. Such type of dual microstructure is acceptable for 304L stainless steel. The average grain size generated of the base metal was determined using a linear intercept technique is found to be 20µm.

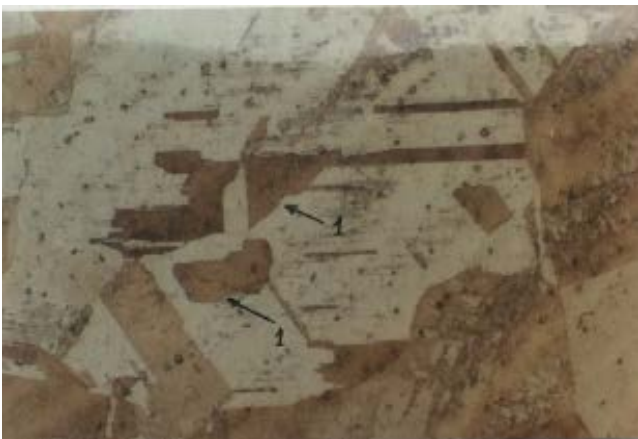
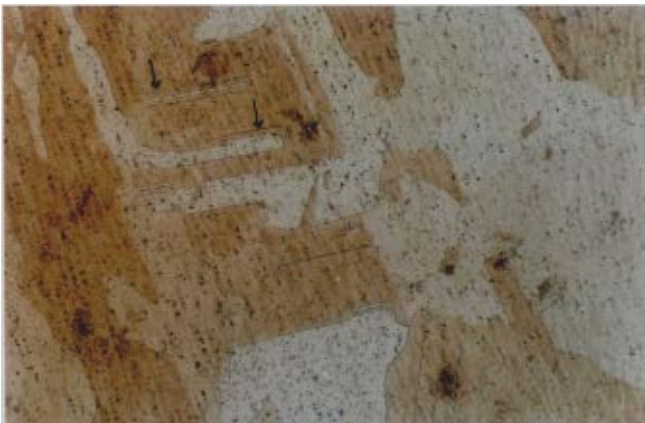
Fig. 5 (a , b and c) Microstructure of the weld metal after repeated solution treatment in three different positions (etched in 10ml HNO₃, 10 ml acetic acid, 15ml HCL, and 2 drops glycerol) – 400X

Representative specimen were given additional solution treatment under the same regime as the claimed one. So the microstructure of the weld metal after repeated solution treatment (Fig. 5) revealed largely recrystallized structure, where small islands of the cast structure was retained. The average grain size of the material was observed to increase substantially during the treatment. Hardness traverser, however, did not show noticeable change. The δ -ferrite content of the weld metal decreased to 2.9 %.
